# Manhole Inspection Summary

Manhole # S07UU\_002MH

Insp Date: **7/19/07 10:43 AM**

**Location** Address: **3601 SPRINGDALE AVE**

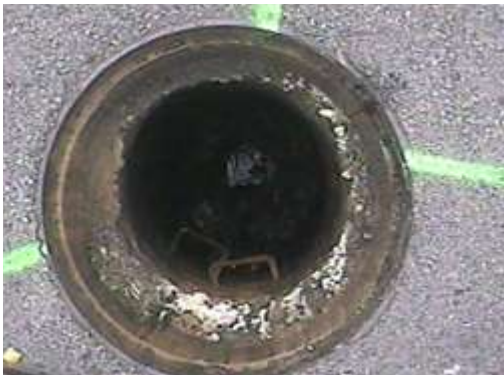
Defect 2

Offset: **4** (in.)

FRAME OFFSET

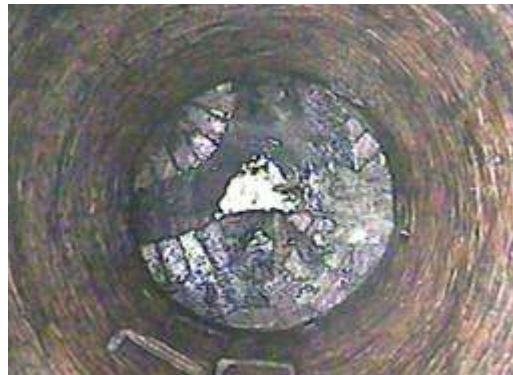
Defect 1

Condition: ☐ Sound ☐ Cracked ☐ Root Intrusion ☐ Deteriorated ☐ Leaks ☒ **Debris**

Count: **6** Missing: **0** ☒ **Corroded**

CORRODED STEPS AND DEBRIS

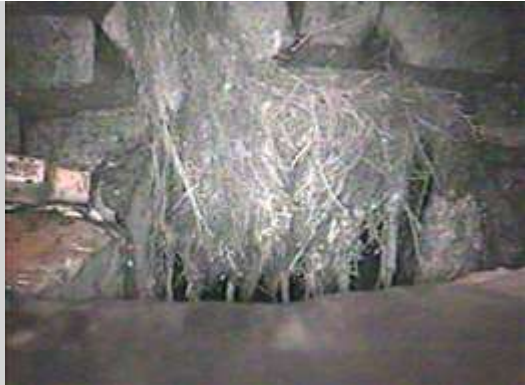
12 O'Clock Outflow

10 in. Circular Gravity Sewer  
Pipe Out @ 12 O'Clock

Pipe Height: (in.) Direct  
Pipe Material: **Clay** ☐ Pipe Lined  
Invert Depth: **12.26** (ft.) Flow Characteristics: **Slow**  
Deposits: ☒ None ☐ Mud ☐ Sludge ☐ Debris ☐ Grease  
Silt Depth: (in.) Deposits Extent:  
Infiltration: **Evidence** Pipe Seal Cond: **Roots**

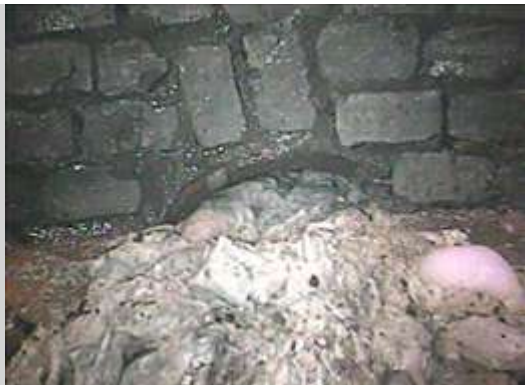
3 O'Clock Inflow

8 in. Circular Gravity Sewer  
Pipe In @ 3 O'Clock

Pipe Height: (in.) Direct  
Pipe Material: **Clay** ☐ Pipe Lined  
Invert Depth: **12.34** (ft.) Flow Characteristics: **Slow**  
Deposits: ☐ None ☐ Mud ☒ Sludge ☒ Debris ☒ Grease  
Silt Depth: **8** (in.) Deposits Extent: **Heavy**  
Infiltration: **None** Pipe Seal Cond: **Sound**

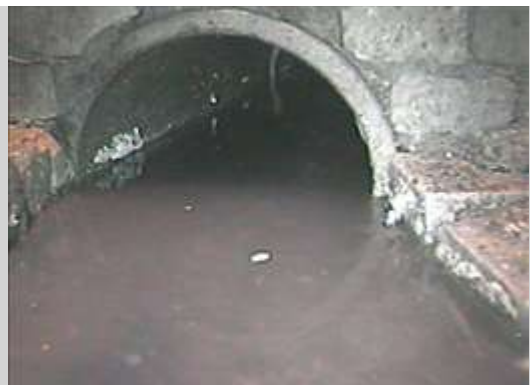
9 O'Clock Inflow

10 in. Circular Gravity Sewer  
Pipe In @ 9 O'Clock

Deposits: ☒ None ☐ Mud ☐ Sludge ☐ Debris ☐ Grease

Infiltration: **None** Pipe Seal Cond: **Sound**
